## **FERROCEMENT FOR HURRICANE – PRONE STATE OF FLORIDA**

**KEYWORDS:** Ferrocement, Hurricane, Damage, Repair, Strength Recovery, Wire Mesh, Mortar

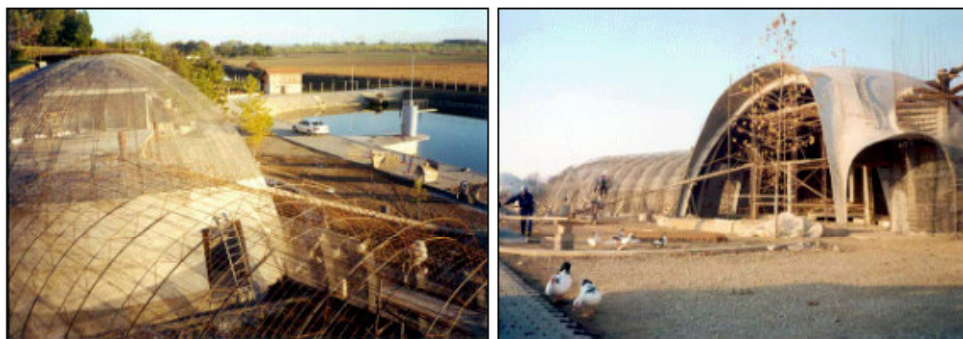
**Figure 1. Sample ferrocement structure - solar home.** (Courtesy: [www.ferrocement.com](http://www.ferrocement.com))

Ferrocement is a type of thin wall reinforced concrete commonly constructed of hydraulic cement mortar strengthened with closely spaced layers of continuous and relatively small diameter wire mesh that may be of metallic or other suitable materials. It is a form of reinforced concrete and is also a composite material where the basic underlying concepts in the behavior and mechanics of materials apply (ACI Committee 540, 1982). A sample ferrocement structure designed by Milenko Milinkovic ([www.ferrocement.com](http://www.ferrocement.com)) is shown in Figure 1.

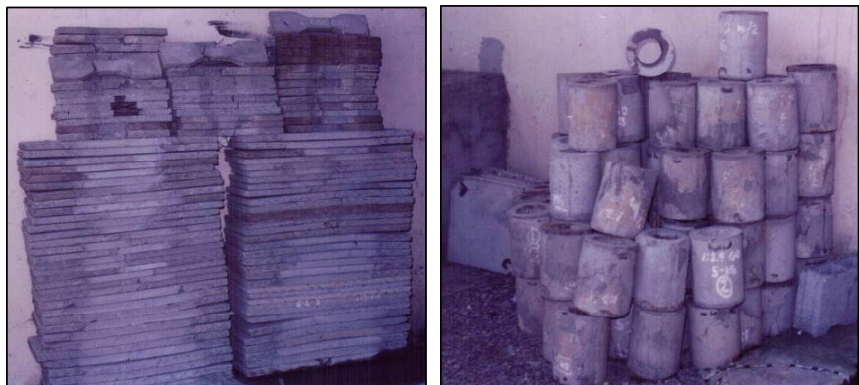
Figure 2. Tested specimens

One hundred sixty two (162) ferrocement specimens shown in Figure 2 were subjected to three types of loading: compression, tension, and flexure; 54 each for compression, tension, and flexure. Eighteen shear specimens were tested but the results needed further investigation and were not included in this paper. In each of the three types of loading, the units were grouped according to cement-sand water

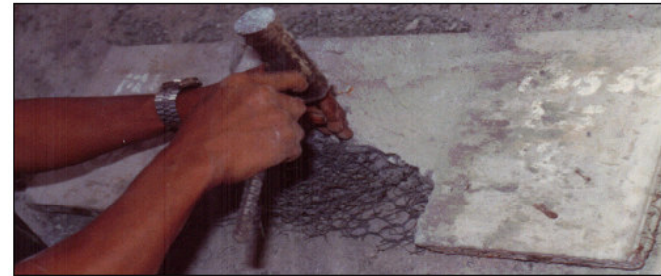
a) Flexure

b) Tension

c) Compression

Figure 7. Repair Method.

Tests to determine the original ultimate strengths of the specimens were done on the seventh day after casting. Each specimen was immediately repaired, cured for five days, and tested on the seventh day after the repair. The process of repair, which was accomplished by hand, varied for each type of specimen. For a flexure specimen, the mortar was chipped off using a hammer and a concrete nail up to a distance of approximately 50 mm from the last visible crack shown in Figure 7a. Wire meshes with strained or ruptured strands were repaired by placing new sets of wire mesh. The ends of the strands of the new sets of wire mesh were secured to the original mesh by creating hooks. As shown in Figure 7b, the same repair procedure was done on tension specimens but only 30 mm of mortar from the last visible crack was chipped off.

In repairing compression specimens, approximately 20 mm of mortar from both sides of visible cracks was removed from each original specimen. As illustrated in Figure 7c, the full depth of mortar was chipped off using a hammer and a concrete nail. Portions of the mesh layers that were exposed after chipping off were reinforced with additional layers of mesh. After removing the presumably damaged mortar, the same mortar mixture was prepared and plastered on each chipped specimen until the original shape was obtained. The plastering was done by pushing the fluid mortar on the mesh cage from one side until excess appeared on the opposite face. The excess was then pushed back and the surface was flush finished. A trowel was used to place a stiff mortar.

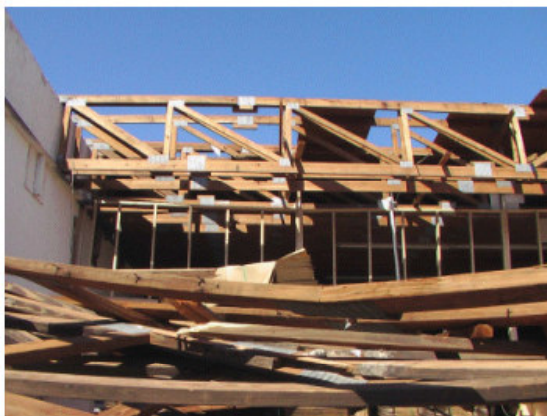
a) Hurricane roof damage

b) Structural model

Figure 12. Collapse of roof due to loss of roof deck lateral bracing.

There were few cases where non-structural destruction led to the collapse of the structural framing. An example was a warehouse type building shown in Figure 12 that used rectangular trusses as roof framing. The roof trusses had inadequate cross bracings. When the plywood roof deck was blown off by the wind, the roof trusses became unstable and half of the roof assembly collapsed. Part of the slender reinforced concrete-framed wall filled with concrete masonry units also collapsed due to loss of lateral bracing.

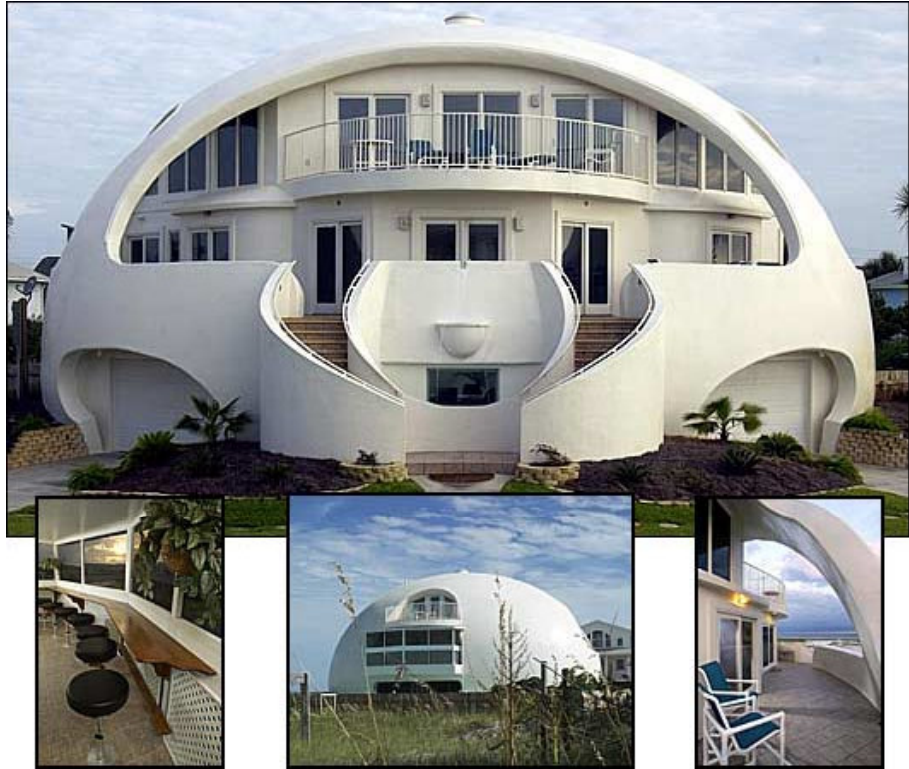
Figure 14. A potential structure for ferrocement technology.

The Dome of a Home in Pensacola, Florida ([www.domeofahome.com](http://www.domeofahome.com)) shown in Figure 14 had illustrated the idea on how ferrocement technology could be beneficial. The owner, while making the repairs to his home after being severely devastated by Hurricanes Alberto, Erin and Opal, kept thinking, "There has to be a better way to build structures to withstand this environment." After researching building techniques that would alleviate extensive hurricane devastation, he came up with a dome-type monolithic structure. Withstanding 483+ kph (300+ mph) winds, storm surges, termites, rising energy costs, fires, and even earthquakes, air form concrete domes were claimed indestructible. The owner had proven that it was a true sanctuary, a place to come home to even after a hurricane.
